**Flood Control Project Maintenance  
Levee Inspections**

**2015 Channel Summary Report**

## San Joaquin County Flood Control and Water Conservation District

### Duck Creek Diversion Channel

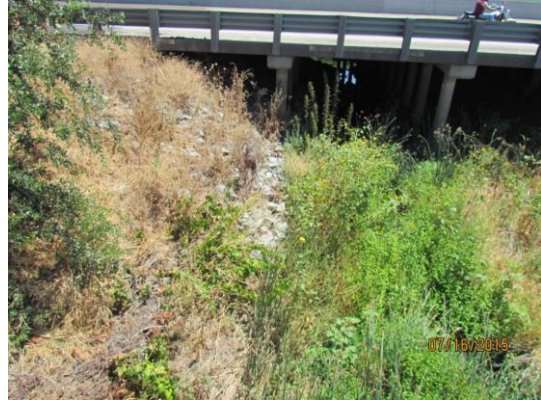
Photo 1 of 1 : CH\_2015\_NA0017\_44\_89\_20150818\_00089.jpg

Check Point / View				
Highway 99 / Down (cont)				
Rating **	A	Issue No.	89	GPS Lat/Long
Issue Type +	Ma	Location *		37.872077 °
Category	Rivers, Channels & Designated Flood			-121.219318 °
Item	Revetments			
DWR ID	DWR_NA0017_44_c _ 2012_89			
Action/Comments				
Inspector Comments: Existing riprap was properly maintained at this location.

View of the existing revetments on the downstream end of the channel.

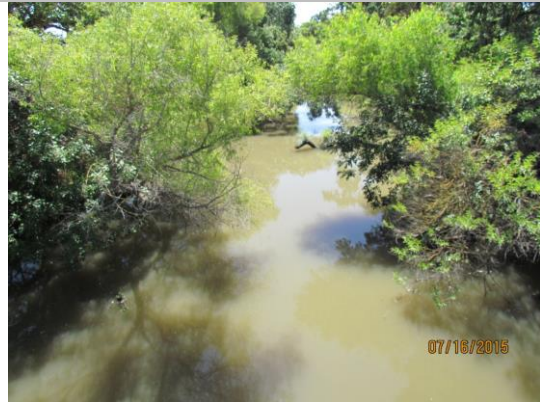
Photo 1 of 1 : CH\_2015\_NA0017\_44\_120\_20150818\_00086.jpg

Inspector Comments: Minimal vegetation may not impede the flow of the channel. Tree branches may fall in the channel in future.

View of the channel looking upstream.

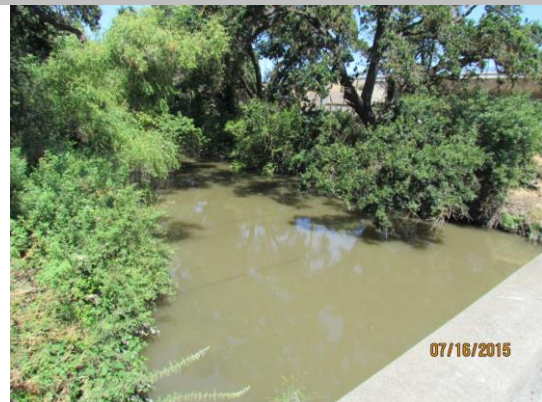
Photo 1 of 1 : CH\_2015\_NA0017\_44\_125\_20150818\_00087.jpg

Inspector Comments: Tree branches may fall into the channel, but the flow is not impeded.

View of the vegetation on the downstream of the channel.

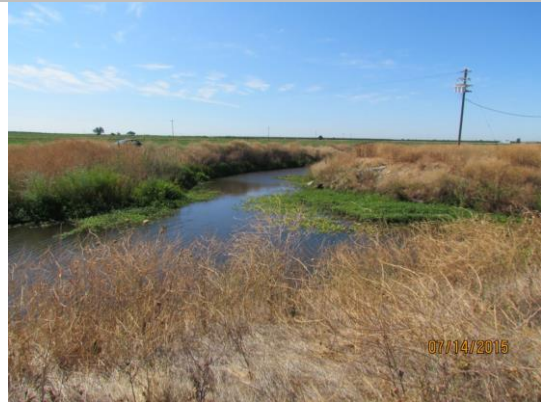
Photo 1 of 1 : CH\_2015\_NA0017\_45\_6\_20150818\_00016.jpg

Rating **	A	Issue No.	6	GPS Lat/Long
Issue Type +	Ma	Location *		37.888860 °
Category	Rivers, Channels & Designated Flood			-121.130320 °
Item	Vegetation & Obstructions			
DWR ID	DWR_NA0017_45_c _ 2012_6			
Action/Comments				
Inspector Comments: Minimal vegetation was present in the channel but it may not impede the flow.

View of the confluence looking downstream of the channel.

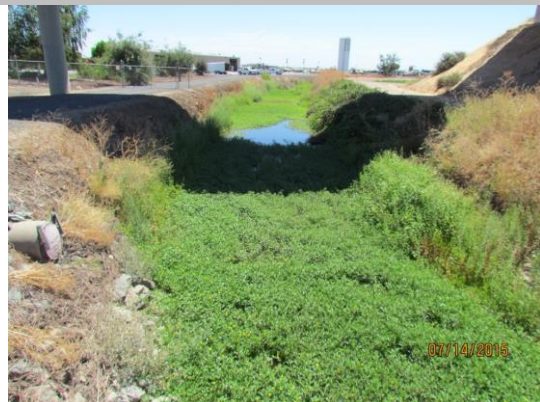
Photo 1 of 1 : CH\_2015\_NA0017\_45\_11\_20150818\_00017.jpg

Inspector Comments: Vegetation growth was found on the channel may impede the flow of the channel.

View of the vegetation upstream end of the channel.

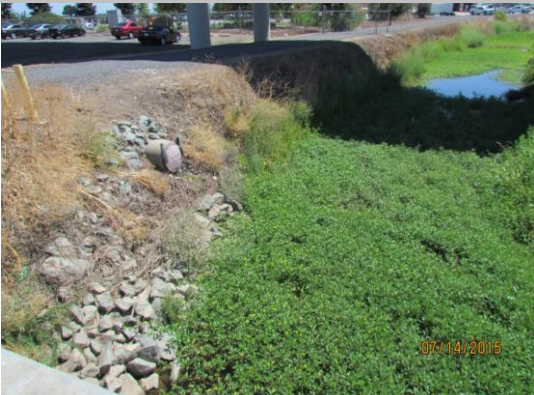
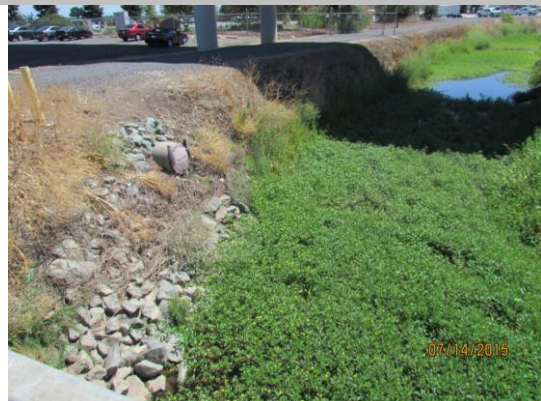
Photo 1 of 1 : CH\_2015\_NA0017\_45\_14\_20150818\_00018.jpg

Rating **	A	Issue No.	14	GPS Lat/Long
Issue Type +	Ma	Location *		37.889520 °
Category	Rivers, Channels & Designated Flood			-121.146980 °
Item	Revetments			
DWR ID	DWR_NA0017_45_c _ 2012_14			
Action/Comments				
Inspector Comments: Existing riprap is properly maintained in this site.

View of the existing riprap on the channel bank looking upstream.

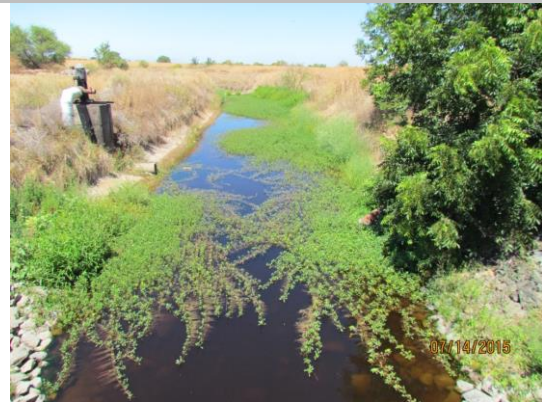
Photo 1 of 1 : CH\_2015\_NA0017\_45\_16\_20150818\_00019.jpg

Check Point / View				
Jack Tone Rd / Down				
Rating **	A	Issue No.	16	GPS Lat/Long
Issue Type +	Ma	Location *		37.889520
Category	Rivers, Channels & Designated Flood			-121.146980
Item	Vegetation & Obstructions			
DWR ID	DWR_NA0017_45_c _ 2012_16			
Action/Comments				
Inspector Comments: No vegetation was obstructing the flow of the channel.

View of the channel looking downstream.

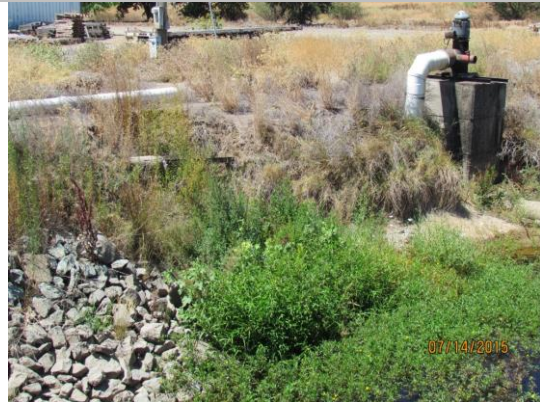
Photo 1 of 1 : CH\_2015\_NA0017\_45\_18\_20150818\_00020.jpg

Inspector Comments: Minor erosion or bank caving is present.

View of bank erosion on the downstream of the channel.

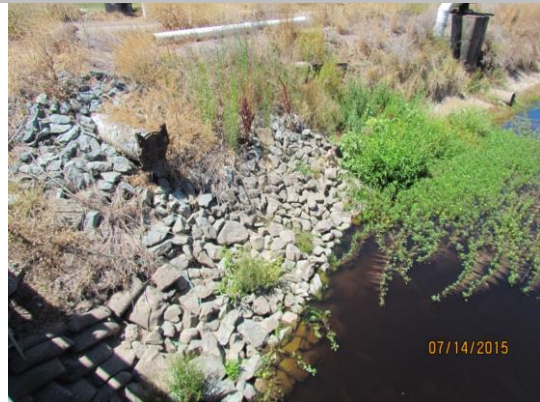
Photo 1 of 1 : CH\_2015\_NA0017\_45\_19\_20150818\_00021.jpg

Inspector Comments: Existing revetments appeared to be properly maintained.

View of the existing revetments on the channel bank looking downstream.

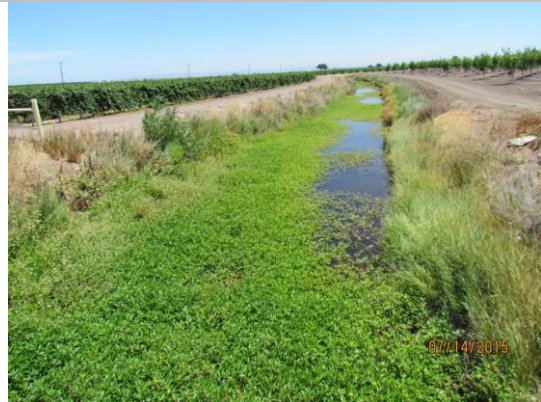
Photo 1 of 1 : CH\_2015\_NA0017\_45\_21\_20150818\_00022.jpg

Rating **	A	Issue No.	21	GPS Lat/Long
Issue Type +	Ma	Location *		37.886056
Category	Rivers, Channels & Designated Flood			-121.183664
Item	Vegetation & Obstructions			
DWR ID	DWR_NA0017_45_c _ 2012_21			
Action/Comments				
Inspector Comments: Minimal vegetation may not obstruct the flow of the channel.

View of the vegetation on the upstream of the channel.

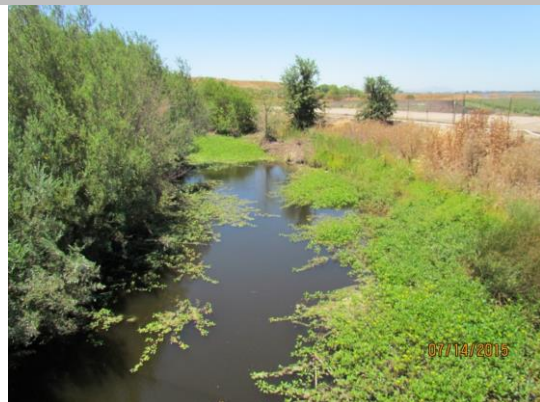
Photo 1 of 1 : CH\_2015\_NA0017\_45\_26\_20150818\_00023.jpg

View of downstream of the channel.

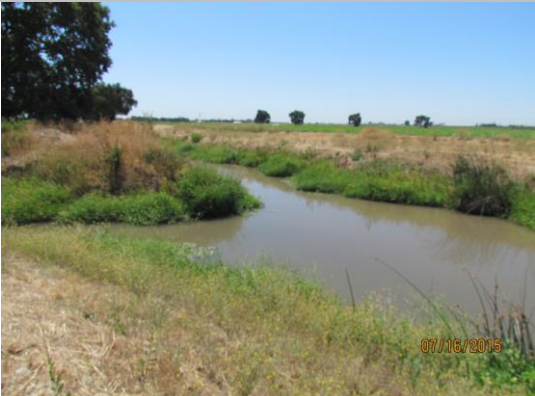
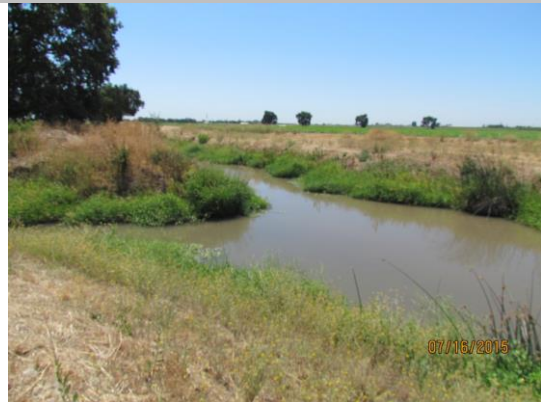
Photo 1 of 1 : CH\_2015\_NA0017\_45\_31\_20150818\_00028.jpg

Check Point / View				
Confluence at Airport Way / Up				
Rating **	A	Issue No.	31	GPS Lat/Long
Issue Type +	Ma	Location *		37.876513 °
Category	Rivers, Channels & Designated Flood			-121.236231 °
Item	Vegetation & Obstructions			
DWR ID	DWR_NA0017_45_c _ 2012_31			
Action/Comments				
Inspector Comments: Minimal scattered vegetation didn't impede the flow of the channel.

View of the confluence looking upstream.

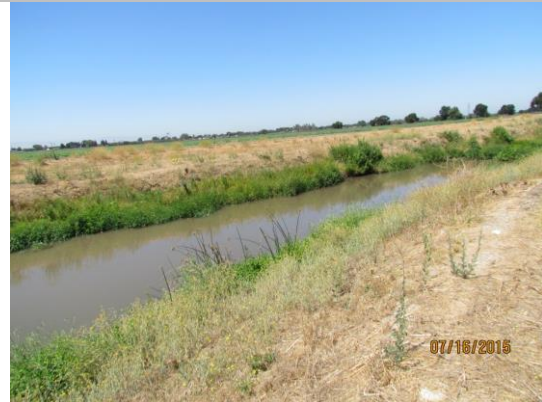
Photo 1 of 1 : CH\_2015\_NA0017\_45\_36\_20150818\_00027.jpg

Inspector Comments: Minimal scattered vegetation didn't impede the flow of the channel.

View of the downstream of the channel.

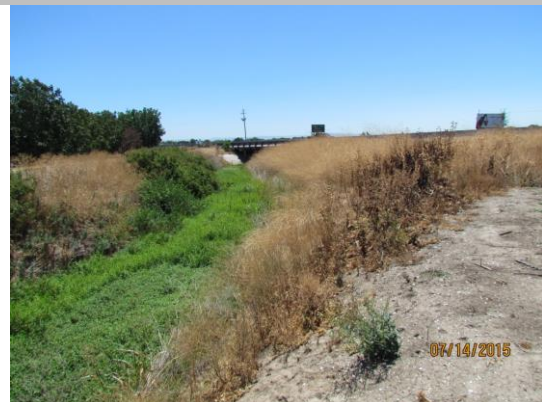
Photo 1 of 1 : CH\_2015\_NA0017\_45\_41\_20150818\_00024.jpg

Inspector Comments: Vegetation may impede the flow of the channel.

View of the vegetation on the upstream end of the channel.

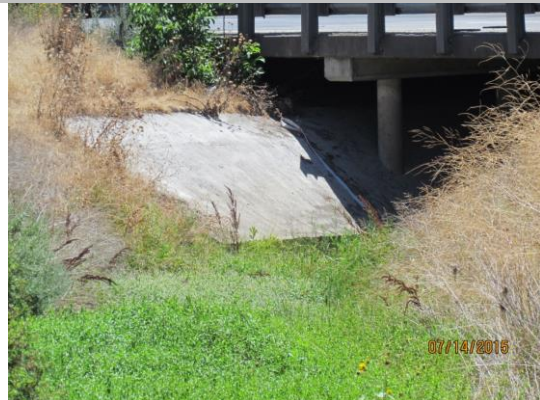
Photo 1 of 1 : CH\_2015\_NA0017\_45\_43\_20150818\_00025.jpg

Rating **	A	Issue No.	43	GPS Lat/Long
Issue Type +	Ma	Location *		37.875127 °
Category	Rivers, Channels & Designated Flood			-121.219201 °
Item	Revetments			
DWR ID	DWR_NA0017_45_c _ 2013_43			
Action/Comments				
Inspector Comments: Existing revetments were properly maintained.

View of the existing revetment looking upstream.

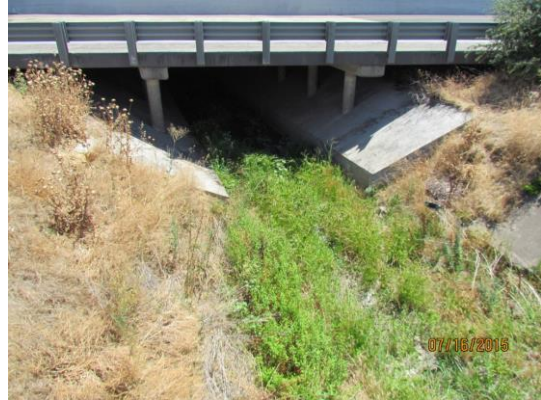
Photo 1 of 1 : CH\_2015\_NA0017\_45\_45\_20150818\_00029.jpg

Rating **	A	Issue No.	45	GPS Lat/Long
Issue Type +	Ma	Location *		37.875127
Category	Rivers, Channels & Designated Flood			-121.219201
Item	Vegetation & Obstructions			
DWR ID	DWR_NA0017_45_c _ 2013_45			
Action/Comments				
Inspector Comments: Vegetation was not imepeding the flow of the channel.

View of the channel looking downstream.

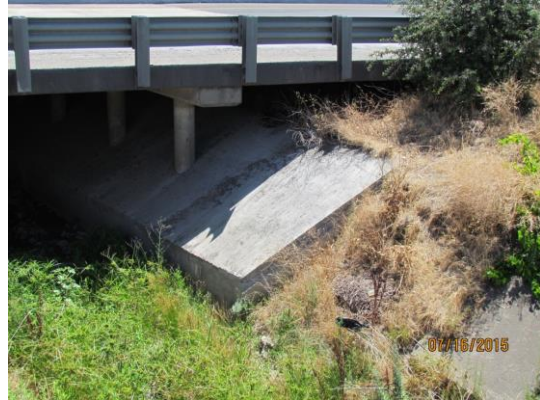
Photo 1 of 1 : CH\_2015\_NA0017\_45\_48\_20150818\_00030.jpg

Inspector Comments: Existing revetments were properly maintained.

View of the revetments on the downstream of the channel.
